Dam ID: HI-0011  
All Reservoir

Inspection No: \_\_\_\_\_  
Date: 3/20/2006

STATE OF HAWAII - DLNR  
VISUAL DAM SAFETY INSPECTION SHEET

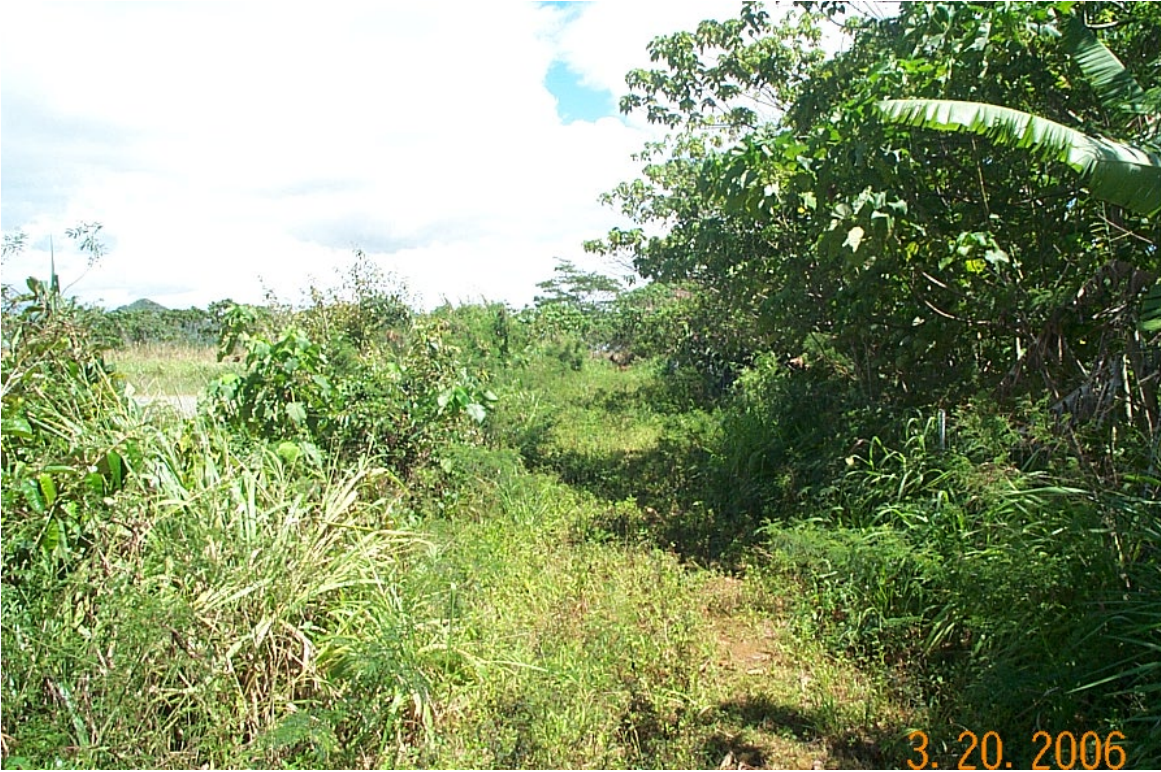
- ☐ i. A sinkhole was observed on the crest, which requires further investigation to determine the underlining cause. Repair and monitor the area.
- ☒ j. Portions of the crest were not visible due to high grass and bush vegetation. Clear high vegetation and maintain low to enable easy visual inspection.

HI00011 - Aii Reservoir: View of the crest of dam. Note the thick vegetation.

1. The upstream and downstream slopes and crest of the embankment should be clear and visible for inspection. Underbrush should be cleared and grasses kept short. Trees have been allowed to grow so large in some cases that there is concern that seepage along the root systems may develop. There is additional concern that cutting and killing the trees will lead to rotten roots and greater potential for seepage. A more in depth evaluation of the vegetation conditions should be performed to determine how best to remediate the condition.

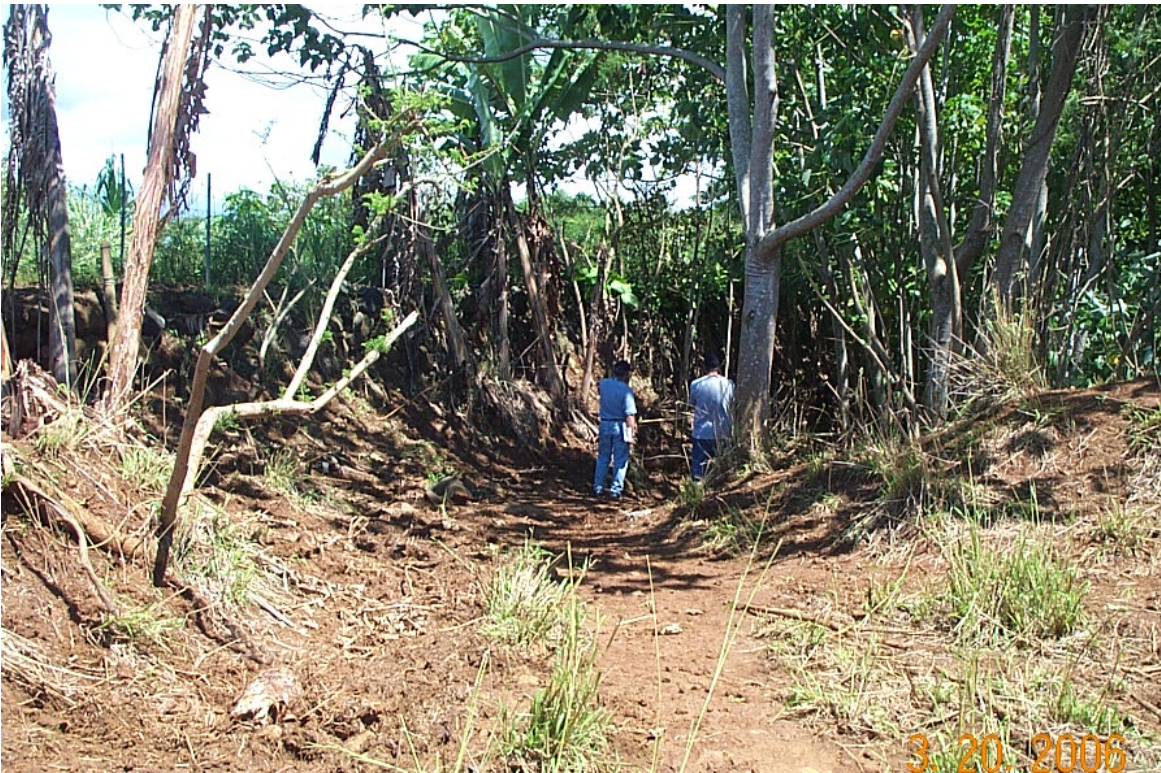
- ☒ j. Grading and cattle traffic have caused the spillway to flow along toe of dam along the right abutment. Owner need to regrade exit channel so spillway flows away from the dam. ***This is considered an urgent corrective action.***

HI00011 - Aii Reservoir: View of potential spillway flow path along downstream toe of the dam. Dam is located on left side of the photo.

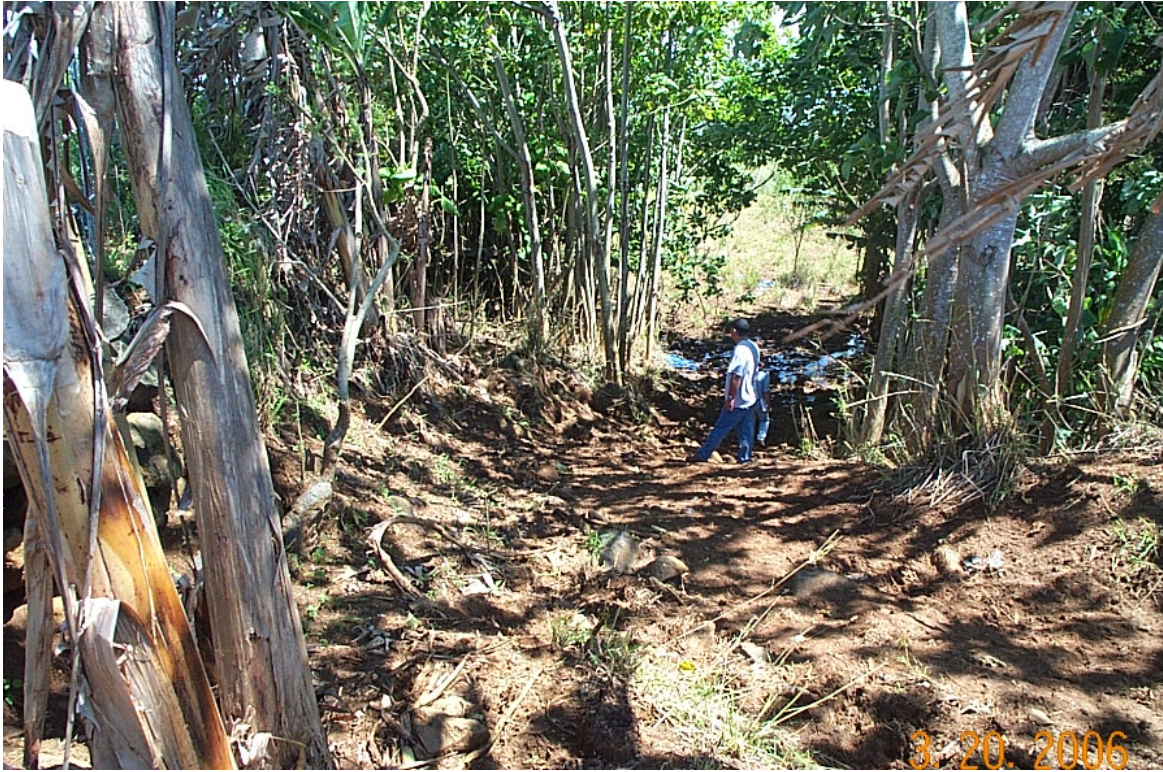
HI00011 - Aii Reservoir: View of potential spillway flow path along downstream toe of the dam.

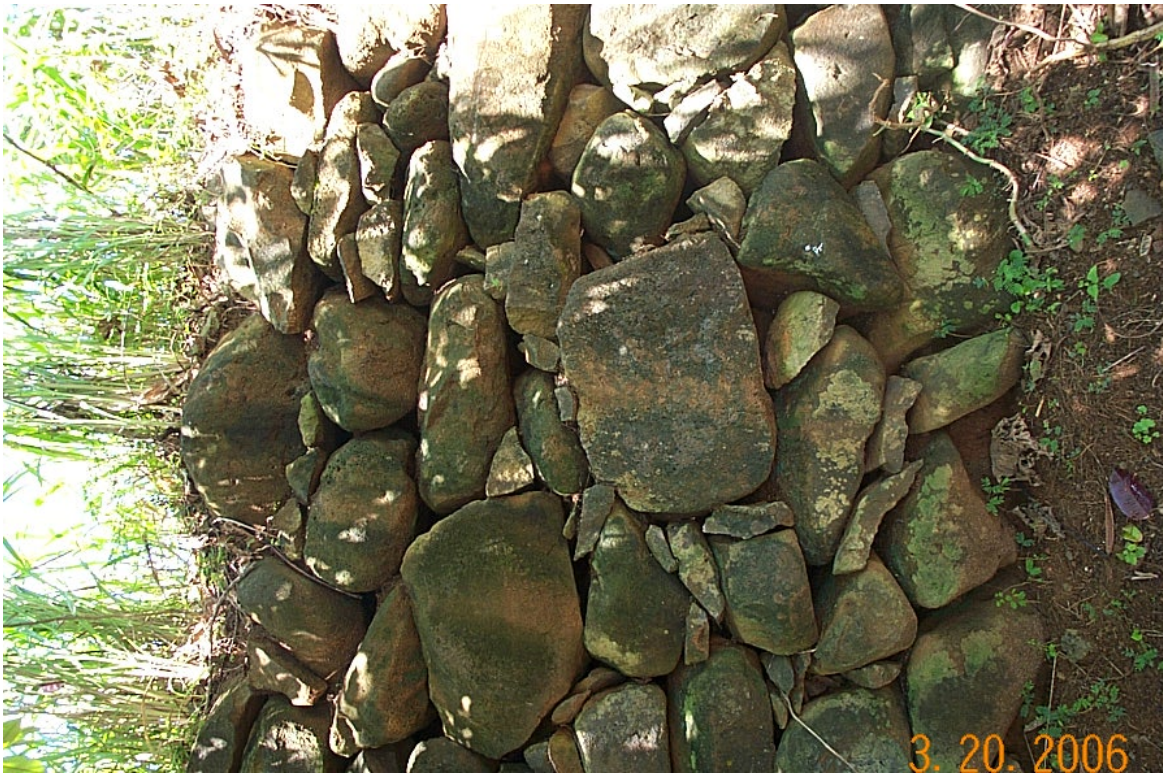
- ☐ j. The slope was very steep, around a 1 to 1 slope, further study is required to verify slope stability.
- ☒ k. Structural engineer should evaluate the condition and stability of the rock wall.

HI00011 - Aii Reservoir: View of the rockwall on the downstream face of dam. Photo is turned 90 degrees counterclockwise.

5. The dam owner should have a structural evaluation conducted on the rock wall to determine the current condition and stability of the wall.
